DEMONSTRATION AND VALIDATION OF THERMAL SPRAY VITRIFICATION OF LEAD-CONTAINING PAINT ON STEEL STRUCTURES

CERL TR 99/61

July 1999

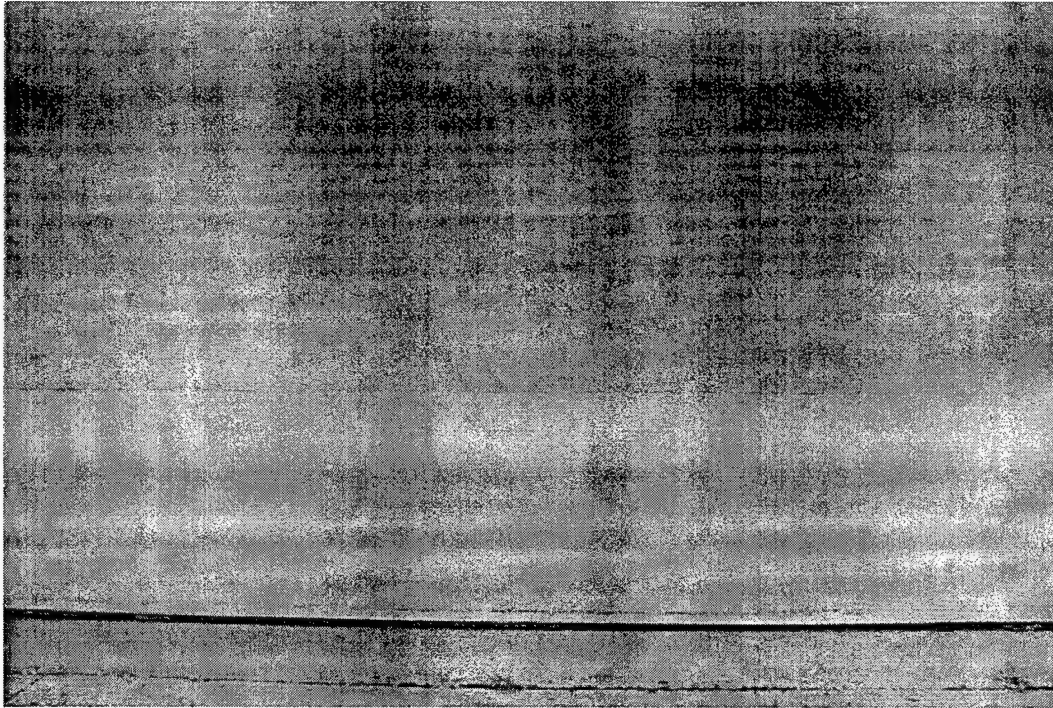
Figure B- 11. Photograph of the hangar door exterior before TSV application.

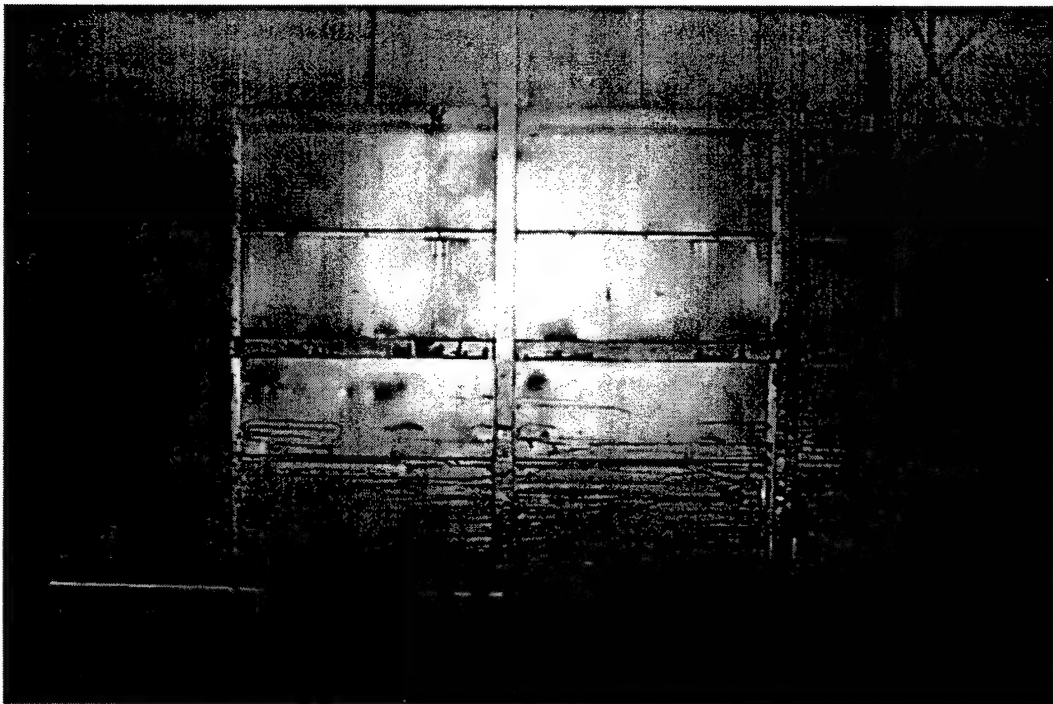
Figure B- 12. Photograph of interior of hangar door before TSV application.

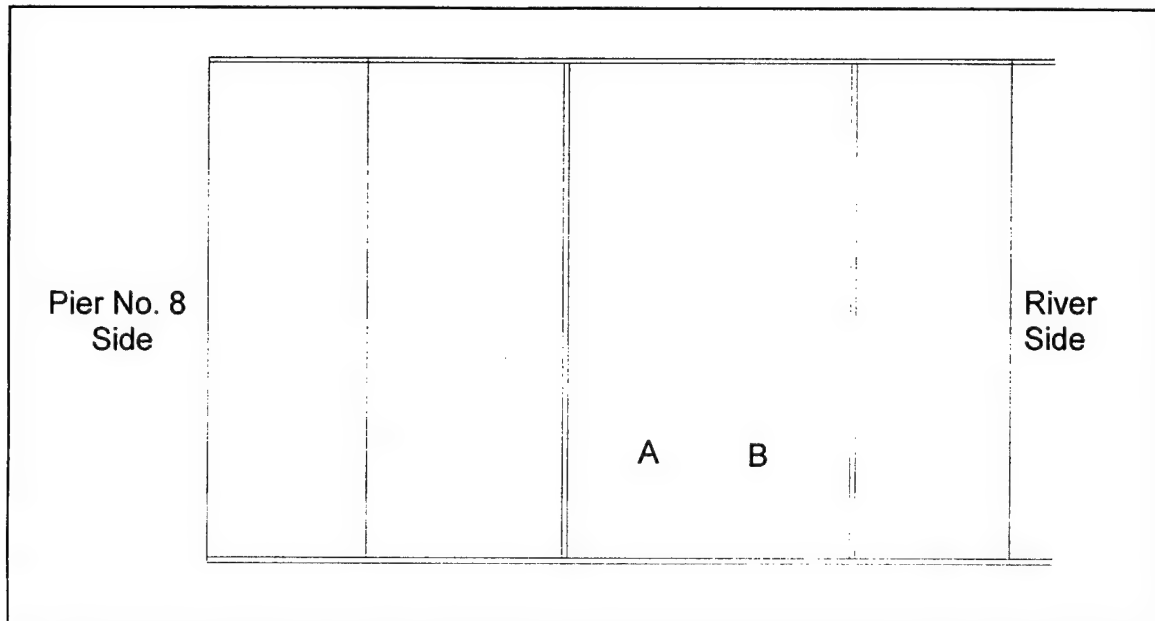
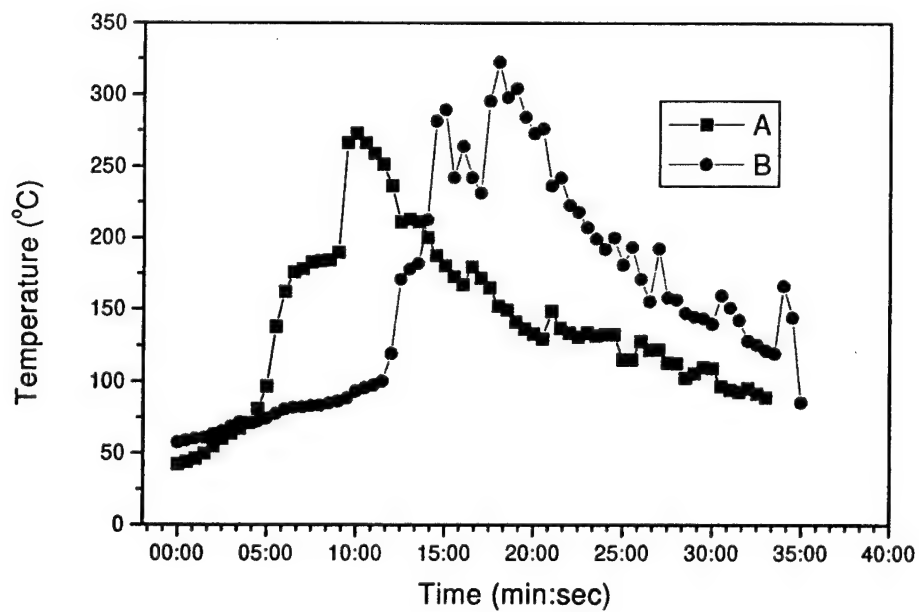
During the initial application of TSV, it was noted by the operator that the vertical web of the beam was warping. The application of TSV was immediately stopped and the degree of warping was measured and found to range up to 3/8 inch. A structural engineer from the Corps of Engineers Rock Island District inspected the beam and concluded that the warping did not adversely impact the structural integrity of the beam or of the bridge. The warping was due to excess heat applied to the vertical web of the beam during preheating of the substrate. The steel temperature on the back of a vertical web of the bridge was measured with a thermal couple during application of the TSV to the front side of the vertical web and is shown in Figure C-3 and C-4. The maximum temperature recorded for the two locations was 273 °C (523 °F) and 322 °C (611 °F).

Figure C-3. Location of steel temperature measurements during TSV application.

Figure C- 4. Steel temperature measurements during TSV application.

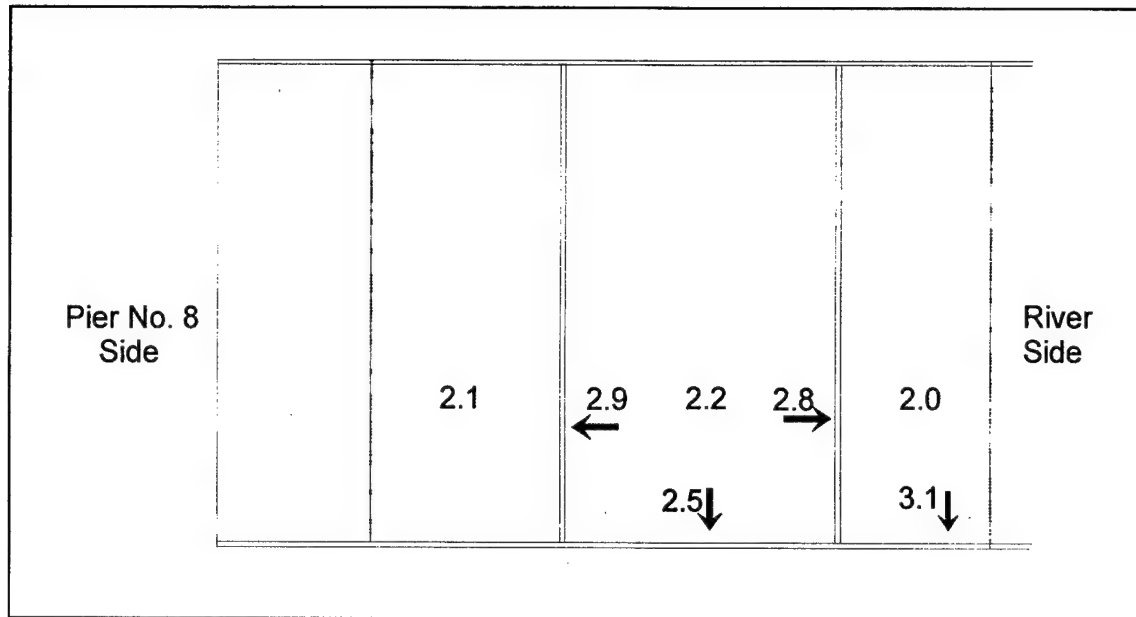
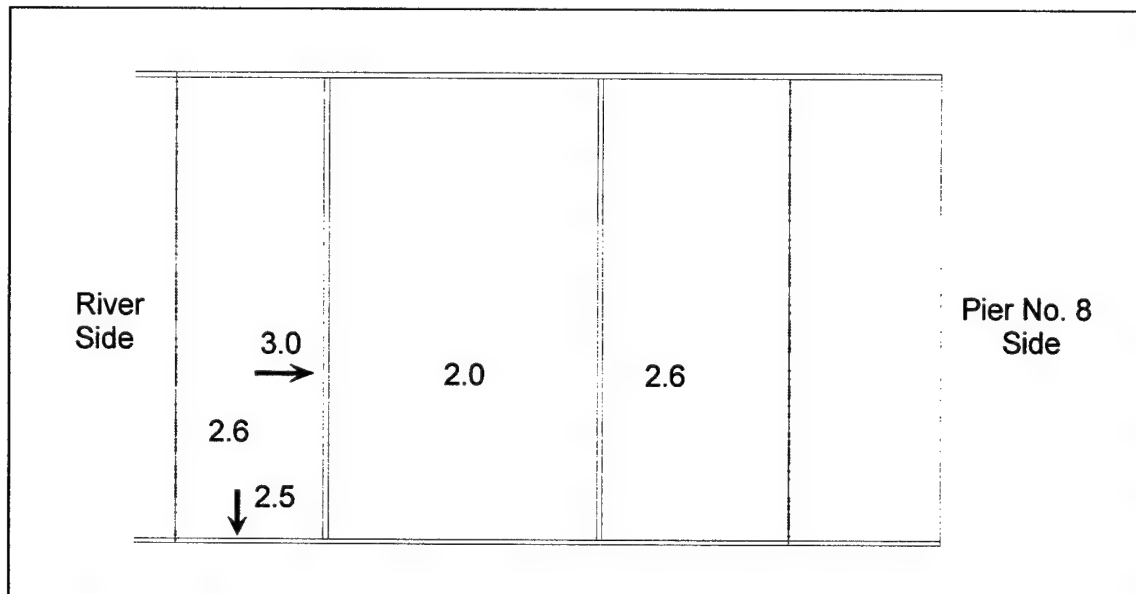
TSV met the principal performance criteria of providing surface preparation for repainting. Following application of TSV, the surface was inspected by personnel from the Paint Technology Center at U.S. Army Construction Engineering Research Laboratory and was found to meet the requirements of the Steel Structures Painting Council (SSPC) SP1 and SP3 required in the contract specification and was suitable for repainting with a surface tolerant coating system. The surface profile was measured using ASTM D 4417 and found to range from 2.0 to 3.0 mils, Figures C-5 and C-6.

Figure C- 5. Surface profile after TSV application (mils), east side.

Figure C- 6. Surface profile after TSV application (mils), west side.

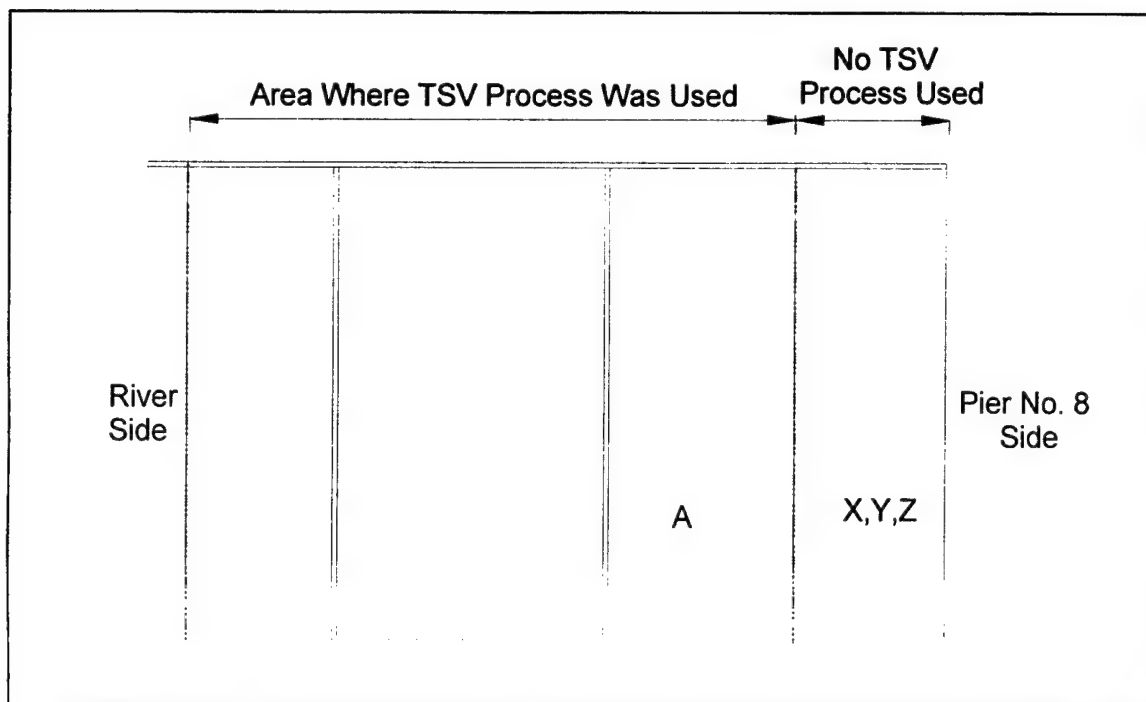
X-ray fluorescence analysis found the lead concentration in areas adjacent to the demonstration with intact original coating ranged from 4.7 to 5.8 mg/cm², Figure C-11 and Table C-7. In areas on which the thermal spray vitrification was demonstrated, the measured lead concentration was found to range from 1.0 to 2.1 mg/cm², Figures C-12 and Figure C-8. As with most other paint-removal processes, such as chemical removal, some residual lead was present on the surface. The aim of this demonstration was to reduce the concentration of lead on the surface to less than 1.0 mg/cm². The retention of lead on the steel surface is a function of the experience of the applicator, the original amount of lead present, and the number of applications of TSV utilized. During the demonstration, two applications of TSV were used. One or two additional applications of the process would be expected to further reduce the residual concentration of lead on the substrate to below 1.0 mg/cm². Experience with the technology also reduces the amount of lead remaining on the surface. The workers in this test had less than 2 days of experience by the end of the test. With a week of on-job experience, the amount of residual lead should also be reduced as the applicators become more proficient. The lead retention does not appear, with the data in hand, to be a function of the lead paint type or age. During any future paint removal from the

Figure C- 11. Location of lead-concentration measurements using x-ray fluorescence spectroscopy with and without TSV application, west side.

Location	Instrument Reading No.	TSV Process Used	Lead Conc. mg/cm ²
A	107.6	Yes	2.12
X	107.7	No	4.70
Y	107.8	No	4.71
Z	107.9	No	5.84
